Unusual Behaviour of an Earth-Rockfill Dam

SYNOPSIS: The post-construction behaviour of a 47.5 m high and 700 m long earth-rockfill dam, located in northwestern Iran, is described. The embankment dam is founded on Tertiary rock on both abutments, but in the river channel it rests on alluvial deposits of variable composition and thickness. Since the first impoundment, the dam has undergone large deformations, both in vertical and in horizontal directions. These have resulted in unusual differential settlements, visible along the crest, and have produced wide longitudinal cracks in the asphalt pavement of the crest road. The principle features of the dam are described and selected monitoring results of the crest movements for a sixteen year period are presented. Based on the analysis of the available data and taking into account the geotechnical characteristics of the foundation and the fill materials, an interpretation of the unusual behaviour has been attempted.

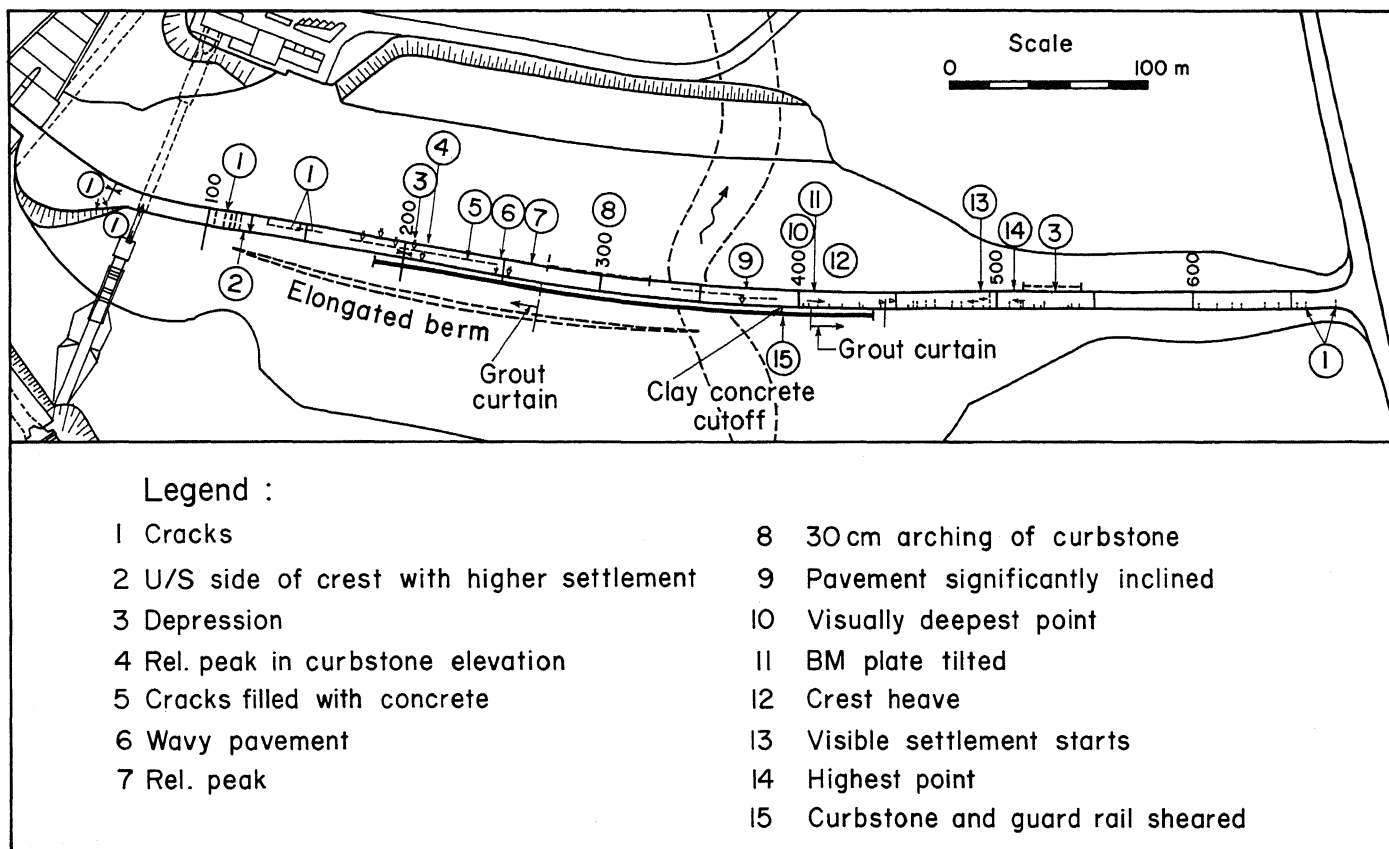
Fig. 5 Crest map showing some of the distress features

The present condition of the crest clearly shows that the dam has undergone a complex pattern of differential movements. Figure 5 shows a map of the crest with some of the more prominent features of distress. The most striking ones are the wavy edge of the D/S curbstone, longitudinal cracks in the asphalt pavement, and a tilting of the crest towards U/S. In the following some more details on the appearance of the crest are given:

- Transversal cracks appear around chainage 0+110 and also from 0+450 to about 0+500. These cracks occur because of differential settlements between the abutments and the valley part and are a common phenomenon for dams on com-

- Longitudinal cracks appeared between chainage 0+120 and 0+250 and again between 0+335 and 0+370. (A crack opened for the first time close to the D/S curbstone on May 1, 1972, when the reservoir level rose to El. 1357.5 for the first time). Some of the cracks had widths of up to 15 cm, and some also showed a vertical offset of the asphalt by as much as 10 cm, whereby the U/S part settled with respect to the D/S part. The cracks were later filled in with sand and mortar and most of them have remained closed since.

- Between chainage 0+265 and 0+325 the D/S curbstone has buckled forming an arch over the underlying rubble fill with an uplift of about 30 cm.
- At about chainage 0+400 compressive forces have sheared the U/S curbstone and guard rail and produced an overlap of the sheared parts.

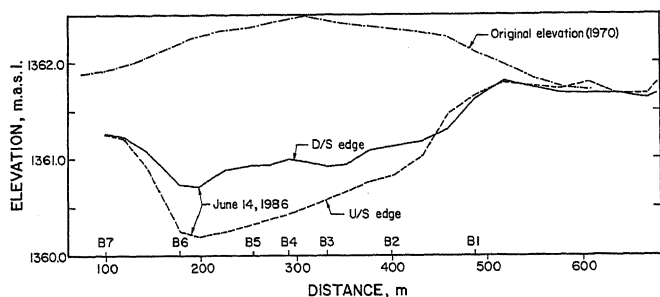
Fig. 6 Differential settlements of U/S and D/S curbstones along dam crest

- There is a considerable tilt of the road pavement towards U/S. The positions of the levelling points on the D/S and U/S curbstones are shown in Fig. 6, together with the original elevation, for June 1986. The largest differential settlement (tilt) between the two curbstones occurs at 0+226, and on June 14, 1986 it had reached 64 cm. (To get the pavement elevation, the height of the curbstone, usually 30 cm, must be subtracted). The camber at this

section was originally 0.85 m and hence the settlement at the centerline of the pavement amounts now to more than 2 m.

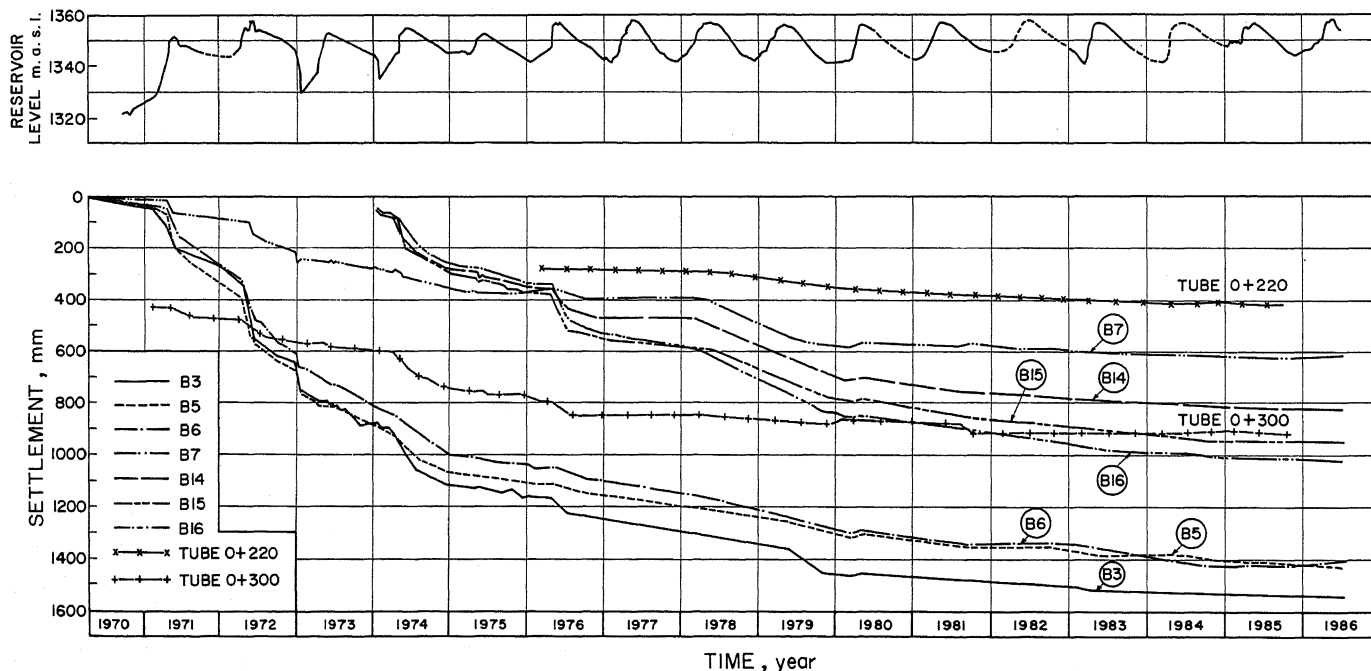
Fig. 7 Vertical components of displacement vectors (settlement) of selected points

The time variation of vertical displacements, i.e. the vertical components of the displacement vectors, of crest benchmarks B3, B5, B6 & B7 and of core benchmarks B14, B15 & B16 are shown in Fig. 7. Also shown are the rates of settlement of the ground surface plates (tubes) at 0+220 and 0+300. The positions of these curves are, however, arbitrary. The value of the total settlement (since June 1968) is obtained by adding 700 mm to the settlement value shown by tube 0+220 and 950 mm to that of tube 0+300. The reliability of these ground settlements is, however, questionable, because there is no sleeve provided between the settlement pipe and the fill material.

During the first phase of fill placement to El. 1346, the settlements of tubes 0+220 and 0+300 were 520 and 830 mm respectively. The corresponding stress increase was approximately 0.55 MPa.

During the following eight months of no fill placement, the settlements increased by 90 and 120 mm respectively. When fill placement was completed in December 1969, additional settlements of 130 and 340 mm respectively had taken place with an estimated stress increase of 0.12 MPa. From these data the constrained modulus of the foundation can roughly be estimated as 10 to 20 MPa (assuming a compressible layer thickness of about 20 m).

For the vertical movements the first four filling and drawdown cycles are of particular interest. During the first year of impounding (1971) the reservoir level reached a peak of 1351. Settlement rates started to increase when the level had reached 1342.5. They decreased soon after the peak had been exceeded. During the second reservoir peak in 1972, settlement rates started to increase when the reservoir level reached El. 1353, and decreased again when it receded to El. 1355. Interestingly, an increase also took place during the very deep drawdown in winter 1972/73. Benchmarks B8, B9 & B10, on the other hand, showed a slight rebound of about 2 cm. No increase in the rates of settlement was observed during the following reservoir peak in spring 1973 which attained only El. 1353. A further increase occurred in summer 1974, especially also with the newly installed core benchmarks B14 to B16. It started when the reservoir level reached about El. 1345. Another increase in settlement rates can be noticed in 1976, but since then settlement rates have decreased steadily without showing a strong relationship with reservoir level fluctuations.

Settlement rates at benchmarks B8 to B13 remained quite small and were not affected by the reservoir level. Tubes 0+220 and 0+300 had a much reduced settlement rate when compared with B3 to B6

The rates of settlement of the top of the clay core, as observed by the shaft benchmarks B14 to B16, were higher than those of the corresponding curbstone benchmarks. For example, since installation at the end of 1973, B16 has settled 1020 mm while B6 has settled only 610 mm. This is because of the rigidity of the curbstone which may cause arching.

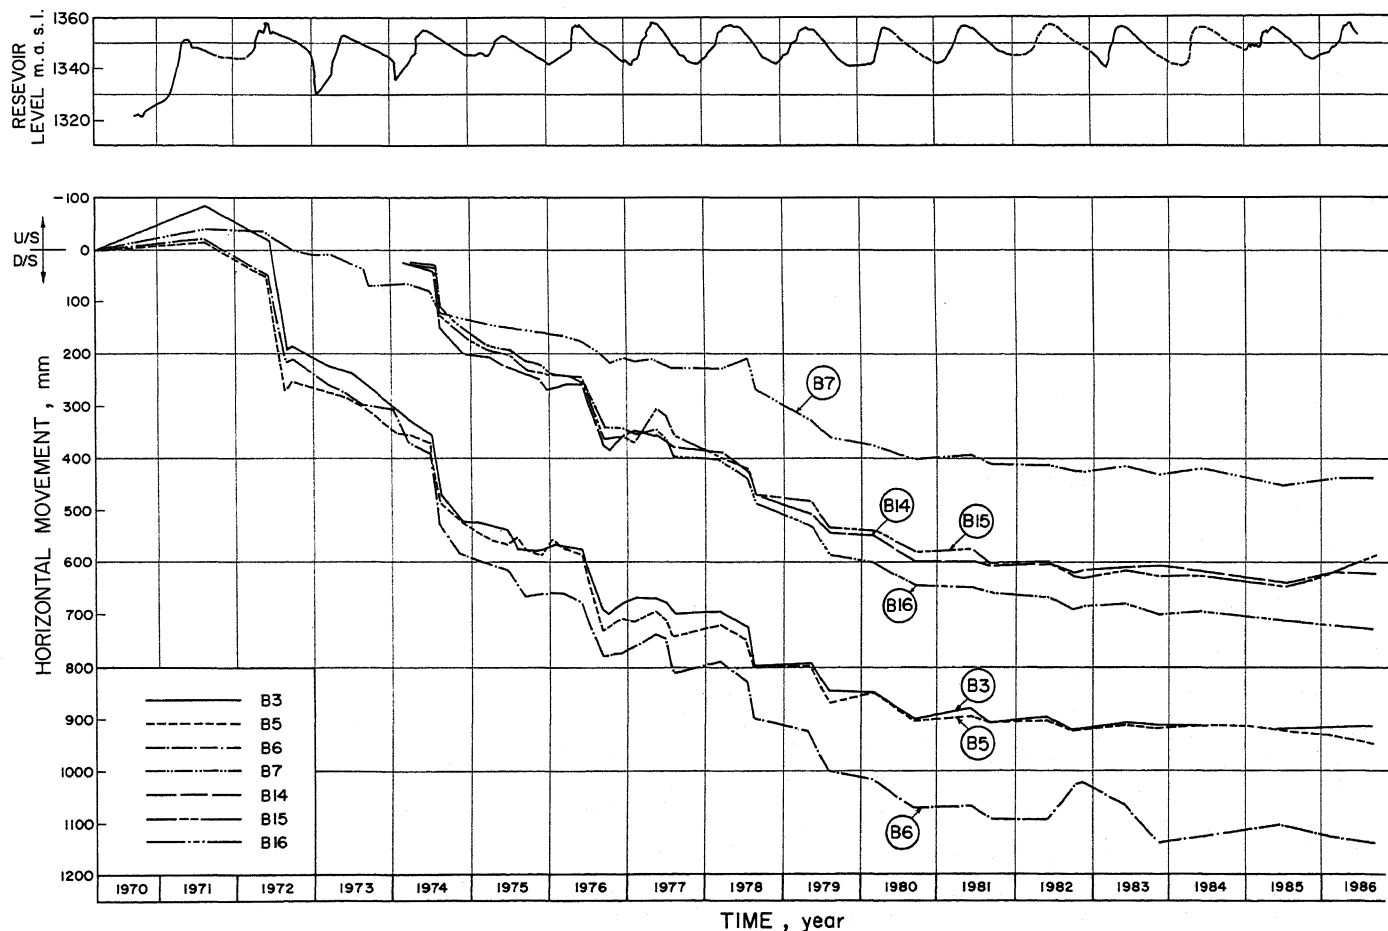
Fig. 8 Horizontal components of displacement vectors of selected benchmarks

Figure 8 shows the time variation of horizontal displacements (i.e. the components of the displacement vectors perpendicular to the longitudinal axis of the dam) of benchmarks B3, B5, B6, B7 and of B14, B15 & B16. It can be seen that during the first filling cycle in 1971, the crest points moved first towards U/S. Only after the peak had been exceeded, i.e. about 4 months after start of impounding, the movements reverted to the D/S direction. Benchmarks on the D/S berm, B8 to B10, on the other hand, always moved towards D/S, but at a much smaller rate.

The time variations of the horizontal displacements are similar to those of the vertical components (settlement), i.e. accelerations in the movements can be noticed when the reservoir level reached 1353 during the 2nd filling in 1972 and again when it reached 1345 during the 4th cycle in 1974. During the deep drawdown in winter 1972/73 there was a small rebound and the crest moved U/S by about 3 cm.

In a horizontal plane the displacement vectors point to the center of the valley, i.e. B1 to B4 move to the left, while B5 to B7 follow a path turning to the right. The displacement pattern with respect to the valley is not symmetric; the largest horizontal displacement has occurred at B6.
